Workshop Manual

Manual on Localising the Ingress of Water

Edition 12.2017

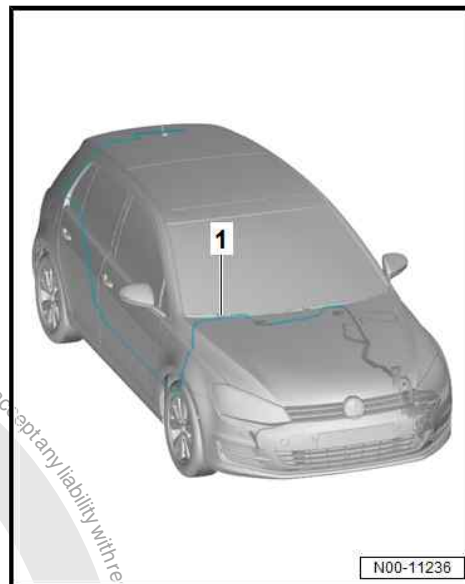
- ◆ Coolant (e.g. water lines and heat exchanger in interior)
- ◆ Windscreen washer fluid (e.g. hose -1- from reservoir to rear window washer system)
- ◆ Condensation from evaporator (e.g. water drain -1- of evaporator blocked)

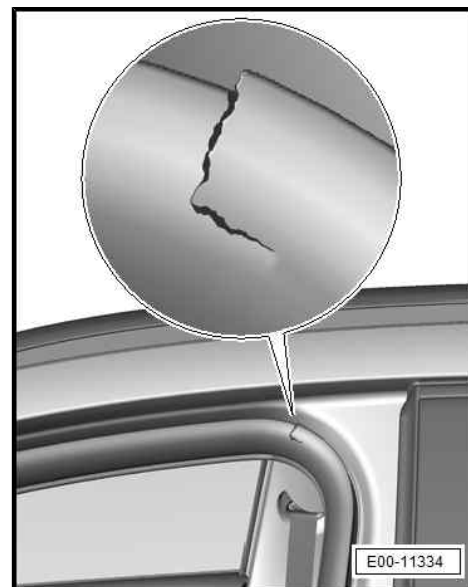
Damaged seals, e.g. on doors, lids and flaps.

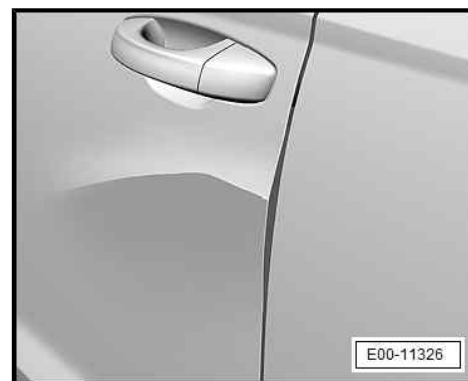
Misadjusted doors, lids, flaps, windows, sliding sunroof panel.

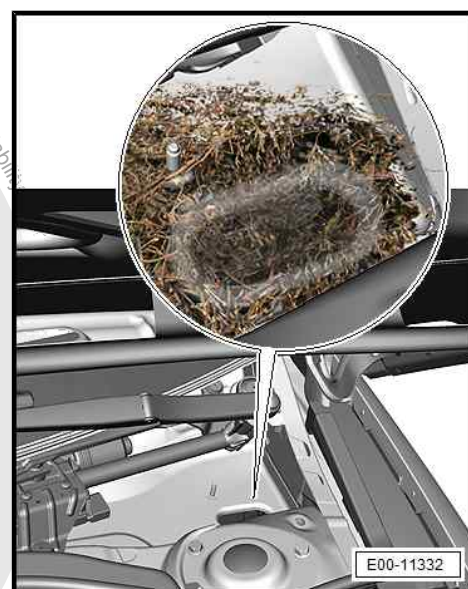
Water drains blocked by foliage and debris.

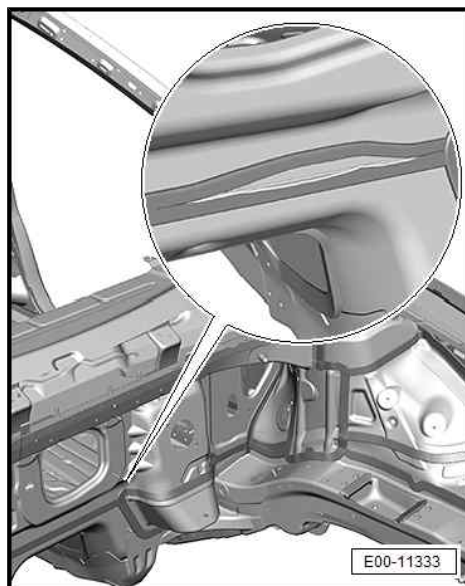
Excess sealant, poorly fitted seals.

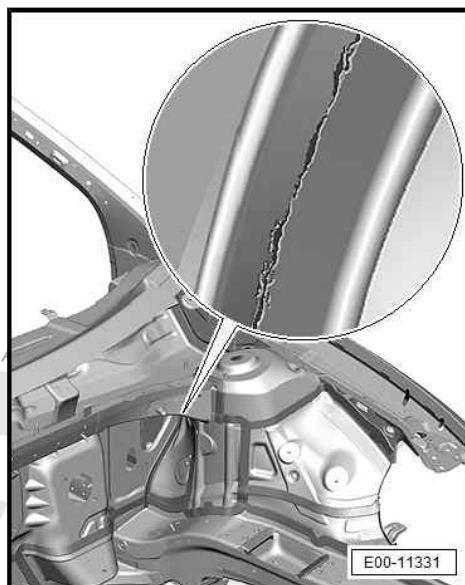
Accident damage not professionally repaired, incorrectly welded panels, spot welds or weld seams burnt through.

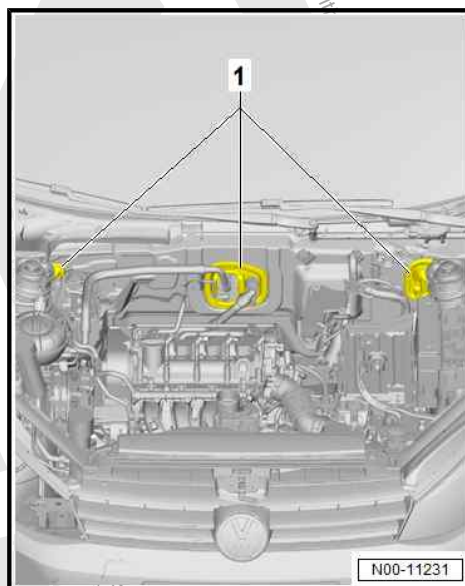
Plugs and grommets -1- incorrectly or only partly fitted.

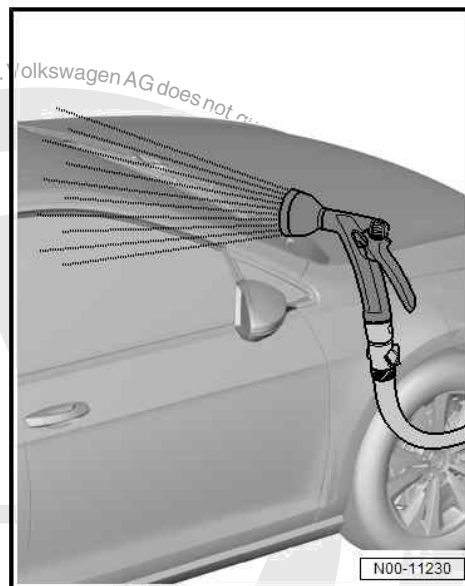
For better identification, a fluorescent leak detector (Liqui Moly 3339) Z 371225 TEA can be poured into a spray bottle according to manufacturer's specifications and sprayed over suspected areas. Inside the vehicle, another fitter traces the course of water using the UV leak detector lamp with safety goggles - VAS 6201/4- .

For details on how to use ultrasonic tester - V.A.G 1842S- and endoscope - VAS 6748A- , refer to the operating instructions accompanying the equipment.

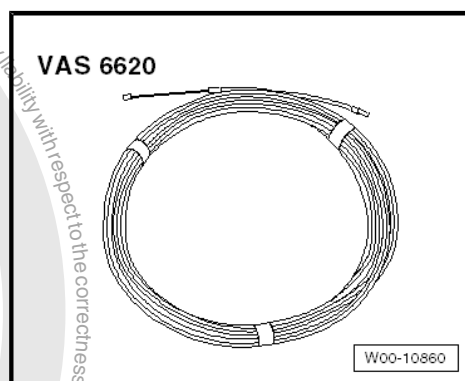
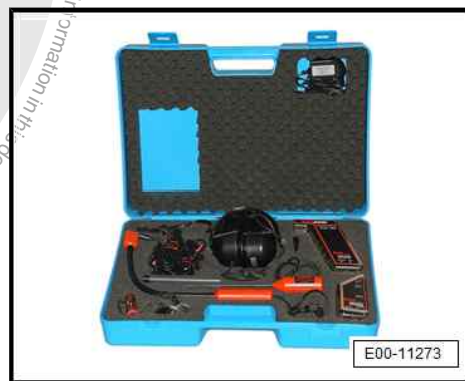
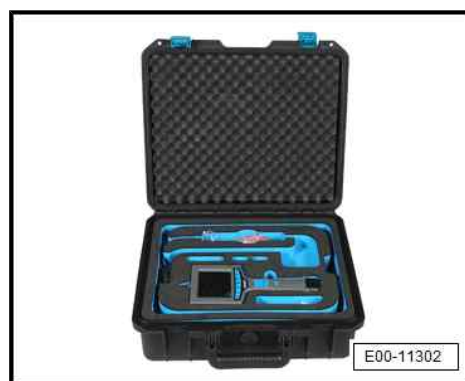
- ◆ Commercially available duct tape
- ◆ Detergent
- ◆ Electric torch
- ◆ Stiff paper (about as firm as a business card)
- ◆ Chalk
- ◆ Water hose with sprinkler head
- ◆ Fluorescent leak detector (Liqui Moly 3339): Z 371225 TEA
- ◆ Pump-action bottle: Z 371439 TE
- ◆ UV leak detector lamp with safety goggles - VAS 6201/4-
- ◆ Cleaning and fitting tool - VAS 6620-

- ◆ Ultrasonic tester - V.A.G 1842S-

- ◆ Endoscope - VAS 6748A-
